YOUR Inspection Report

62 Mordecai Lincoln Road - The Mordecai Home
Scituate, MA 02066

BEACON
STREET
HOME
INSPECTION

RE: Report No. 2043
62 Mordecai Lincoln Road - The Mordecai Home
Scituate, MA
02066

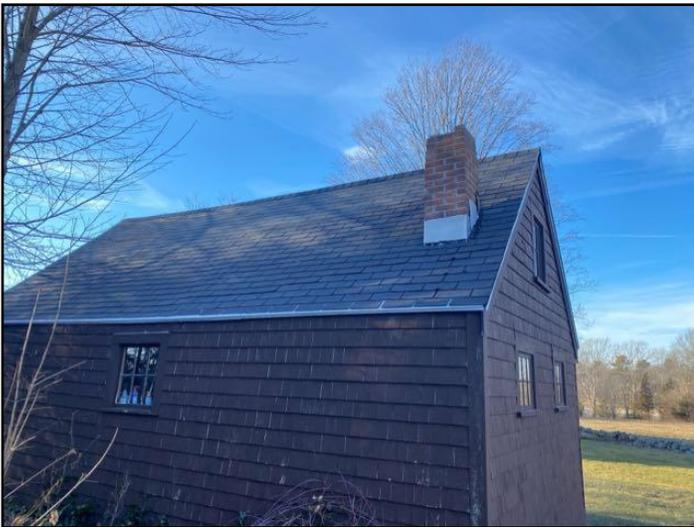
The asphalt shingle roofing covering on the shed structure is well into its useful life and nearing full depreciation. Areas of wear and damage are readily visible particularly on the right gable side. As noted elsewhere in this report, the flashing around the chimney has failed and is allowing water to actively gain access to the roof framing. Improvements will be required for this roof covering.

View of garage roofing

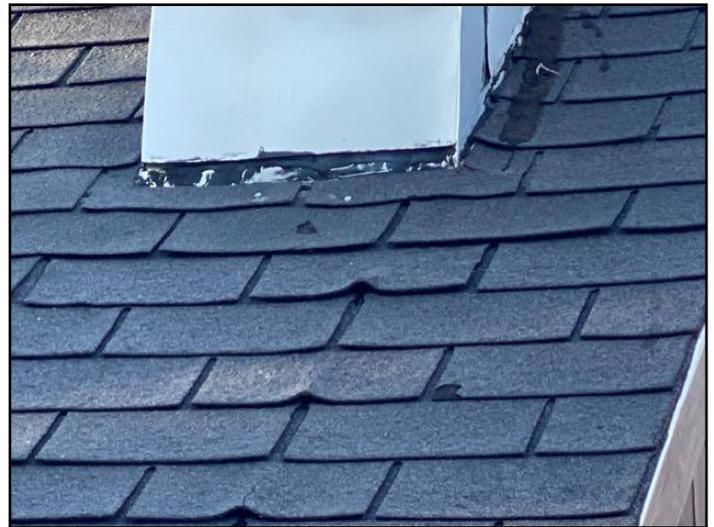
Detail of damage and wear

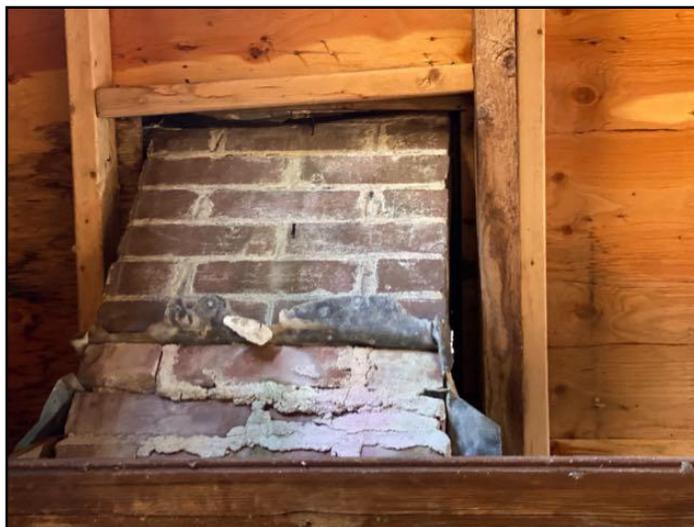
Daylight can be seen around the shed chimney's roof penetration. The flashing for this feature is failing and, as such, is allowing water to gain access to the roof sheathing and framing. This needs to be evaluated by a qualified roofer and promptly repaired.

Failed flashing on shed chimney

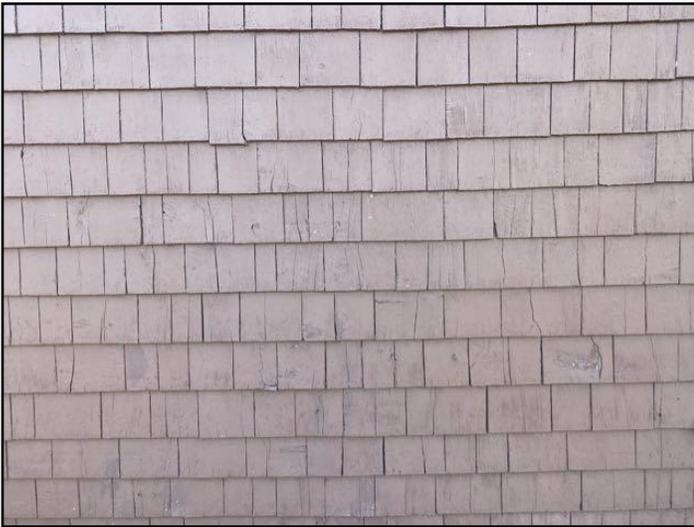
The wood shingle siding on the building is well into its useful life. Significant areas of cracked, damaged, buckling and/or lifting shingles are present, particularly along the right gable end and the rear elevation. While not an item of immediate concern this type of wear is generally considered to be the visual signs of depreciation. At some point in the future, these exterior elevations, starting with the right gable end, will need to be re-sided. This eventual improvement will represent a considerable expense. Recommend you gain a ballpark understanding of what that cost may be and plan accordingly.

Right elevation shingling

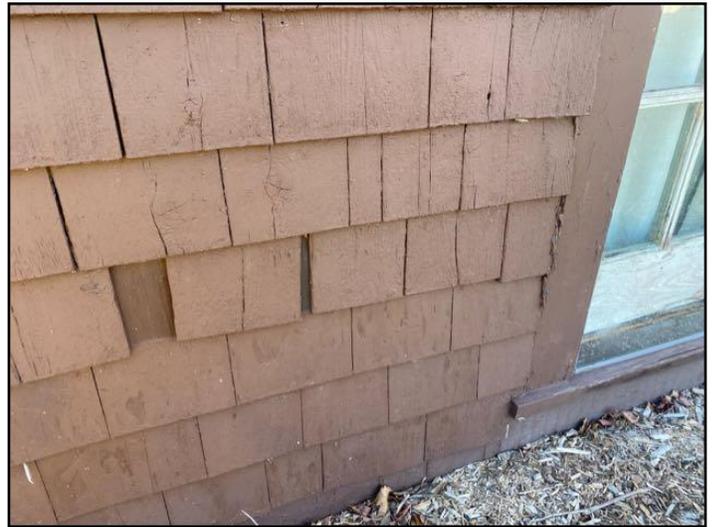
Example of failing siding

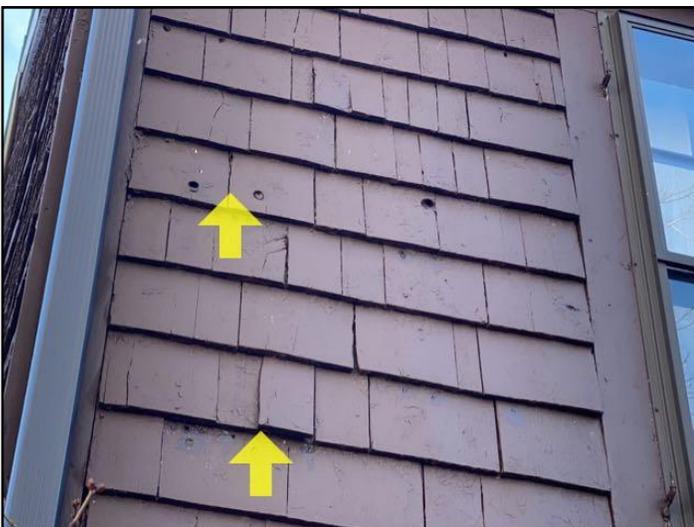
Rear siding

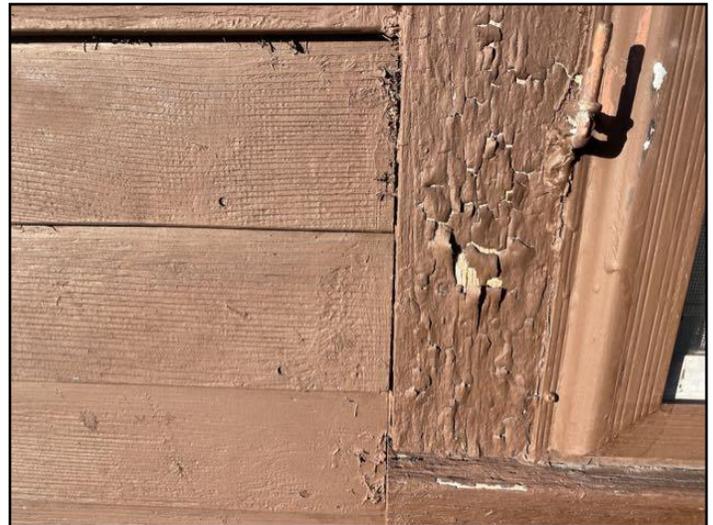
Detail of failing paint films

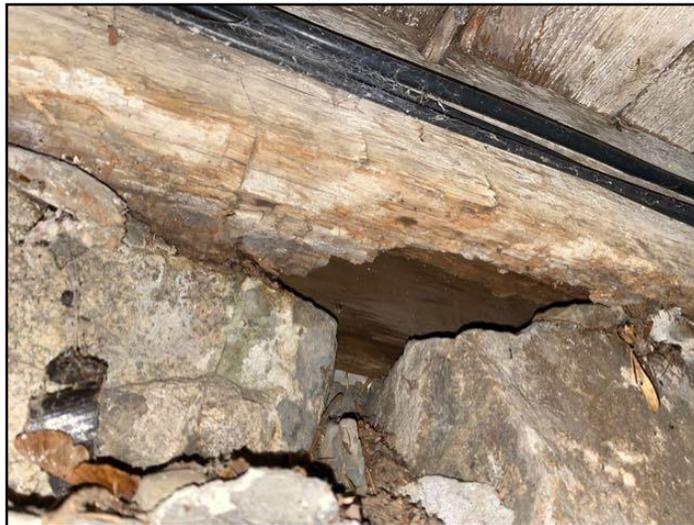
There is a section of visible decay and damage to the front sill near the left corner. The exact length or extent of the damage could not be clearly articulated but visual evidence would suggest that its at least 6-10 feet. This needs to be further evaluated by a qualified contractor. Note: the overwhelming majority of the building's sills and framing were not visible nor accessible due to poor or no clearance in the crawl spaces. There may be other such examples present. Further research is recommended. Sill repair can be a costly endeavor.

Decay in front sill

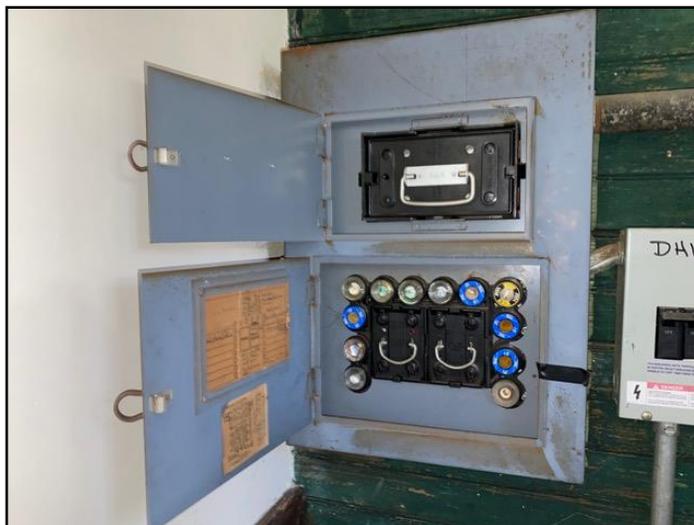
The electrical system, from its fused main panel, to its ungrounded distribution wiring, and its two-prong, ungrounded outlets is obsolete by today's electrical and safety standards. This fused panel has most likely be in use here since at least the 1960s, perhaps longer. Electrical components have anticipated life spans. This panel is beyond its lifespan. Recommend consulting with a licensed electrician to discuss a the scope and cost of upgrading the building's electrical system.

Obsolete electrical system

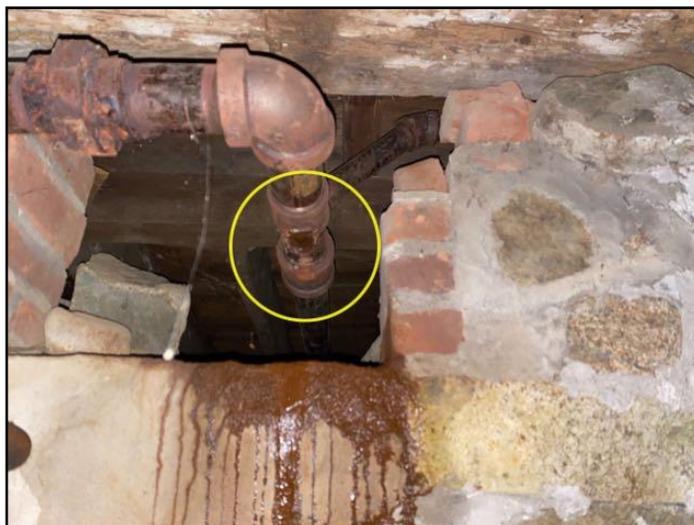
There is an active leak near the front of the cellar hole in a water pipe associated with the boiler. It appears this has been active for some time. This needs to be promptly repaired by a qualified contractor.

Active leak in heating pip

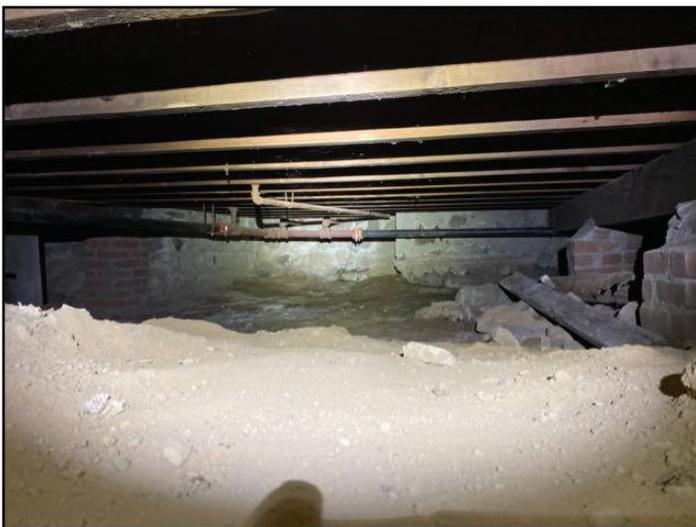
There are numerous crawlspace cavities connected to the left side cellar hole under the building: the rear, left corner, the front right and rear, right and underneath the rear ell addition. All of these crawlspaces contain exposed earth floors. No vapor barriers were noted. Structures are damaged, over time, by water in two main ways: poor exterior drainage systems and ground vapor from beneath them. This building suffers from both. Managing surrounding drainage and ground vapor are critically important factors for the long term well being of any structure. Moisture readings were taken from several framing members throughout the basement and readings were slightly elevated, (18+%). It is almost certain that lower, inaccessible areas of the crawlspaces would contain higher readings. Once moisture content exceeds 20% an environment is conducive to mold, mildew and/or decay. Improvements are strongly recommended. Along with comprehensive improvements in the building's exterior drainage system, a vapor barrier should be installed throughout all crawlspace areas under the building providing 100% coverage. Discuss with a qualified contractor.

No vapor barrier

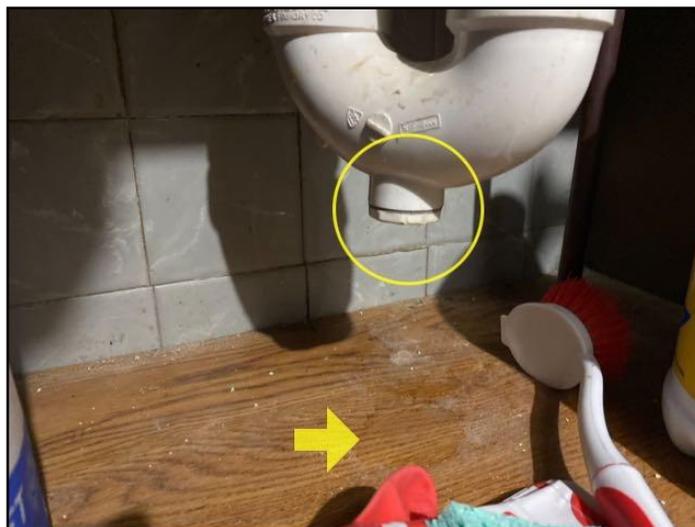
There is an active leak in the drain line assemblage servicing the vanity sink in the rear bathroom on the first floor. This needs to be promptly repaired by a licensed plumber.

Leak in drain line

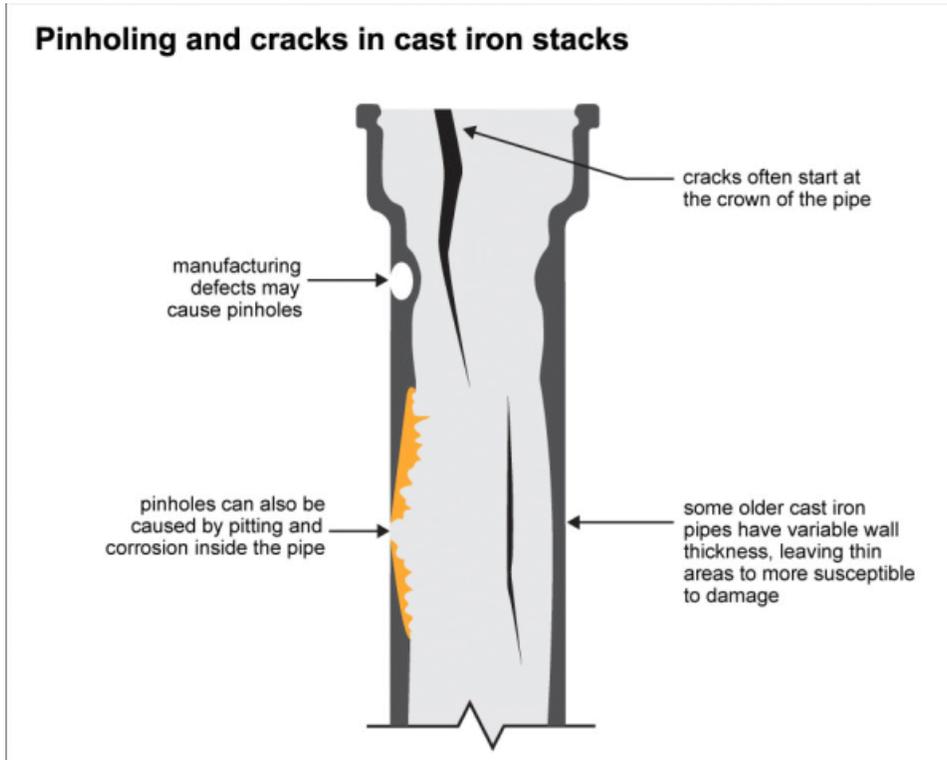
While difficult to see, there is a run of older cast iron drain line along the left side and rear crawl space. Cast iron typically has an expected life span of 50-60 years and oftentimes will rust from the inside-out. While not directly accessible, rusting was noted on several section of this drain piping. Recommend you have it evaluated by a plumber. Upgrading the drain line materials is strongly recommended.

Aging cast iron drain lines

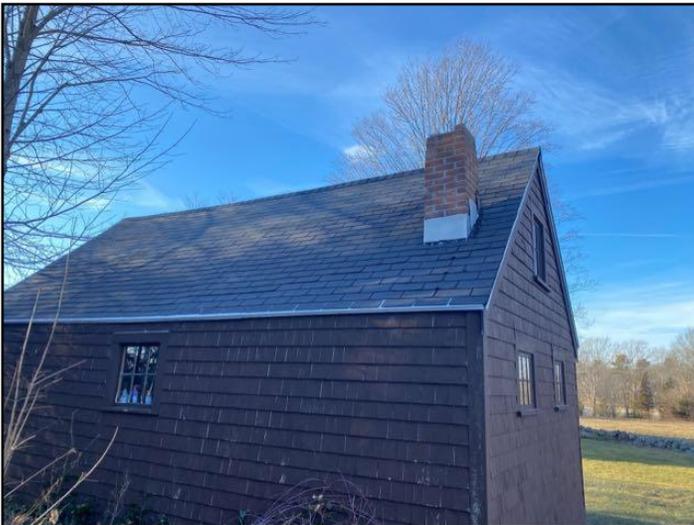
The asphalt shingle roofing covering on the shed structure is well into its useful life and nearing full depreciation. Areas of wear and damage are readily visible particularly on the right gable side. As noted elsewhere in this report, the flashing around the chimney has failed and is allowing water to actively gain access to the roof framing. Improvements will be required for this roof covering.

View of garage roofing

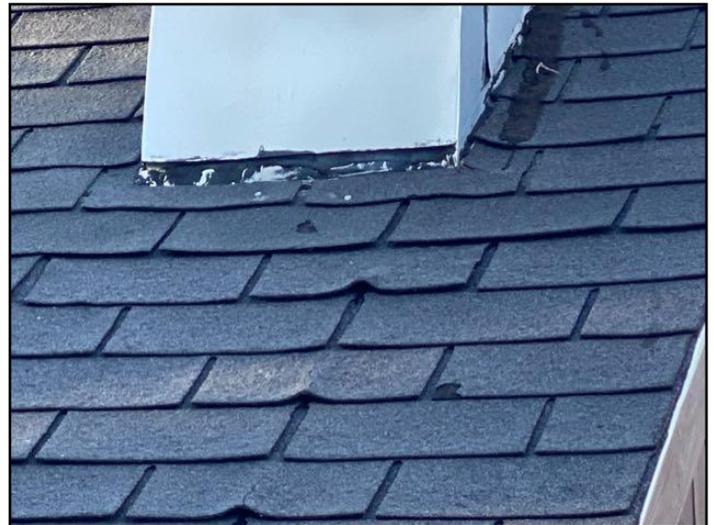
Detail of damage and wear

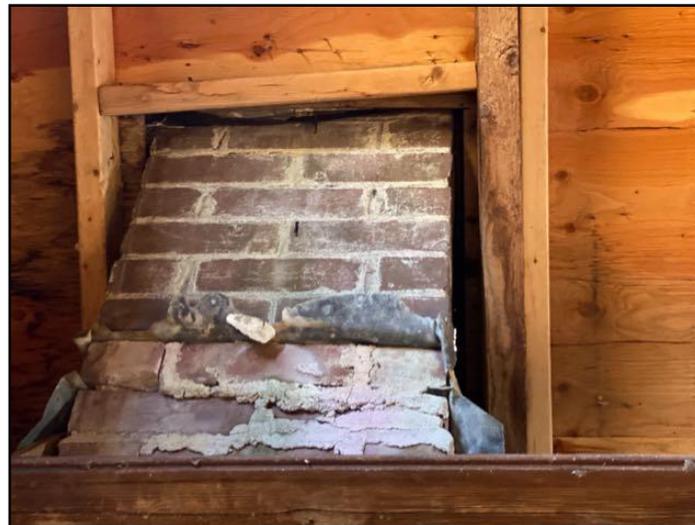
Daylight can be seen around the shed chimney's roof penetration. The flashing for this feature is failing and, as such, is allowing water to gain access to the roof sheathing and framing. This needs to be evaluated by a qualified roofer and promptly repaired.

Failed flashing on shed chimney

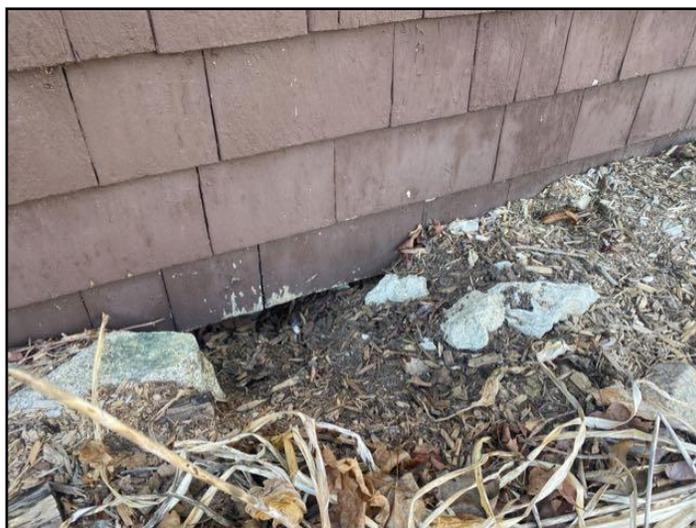
4. Condition: • Pest entry: Numerous points around the exterior display visual evidence suggesting the entrance of rodents and other pests into the structure. These voids can also be seen from within the basement and crawlspaces. Recommend you contract with a qualified pest company to properly seal these voids. In addition, given the age and type of building, it is critically important that this historic structure be the subject of seasonal evaluation and treatment by a licensed pest management company.

Example of entry points

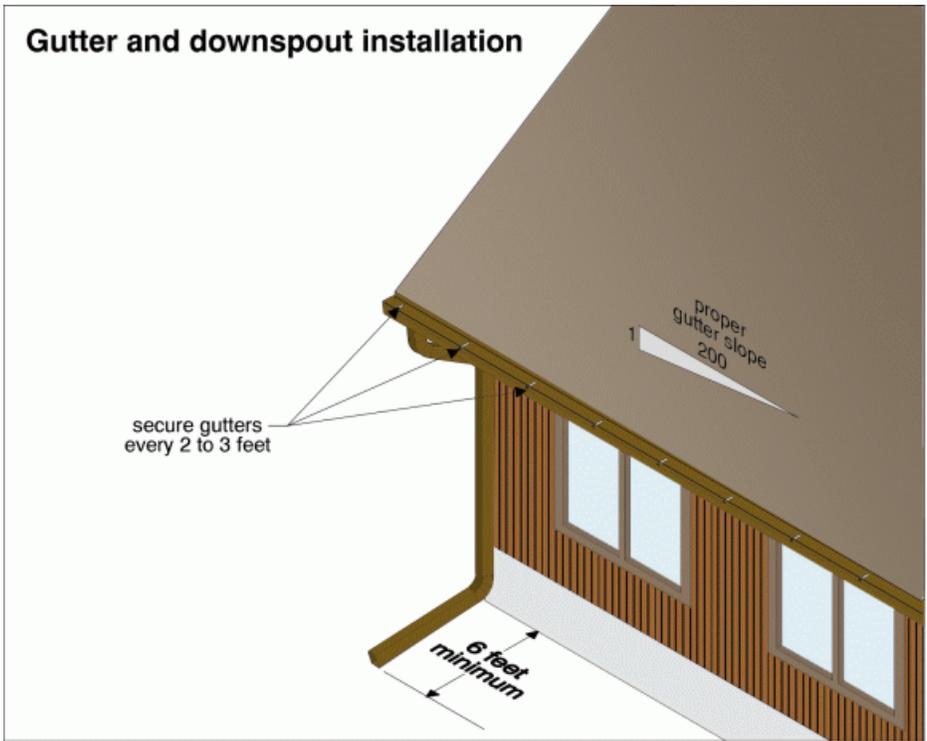
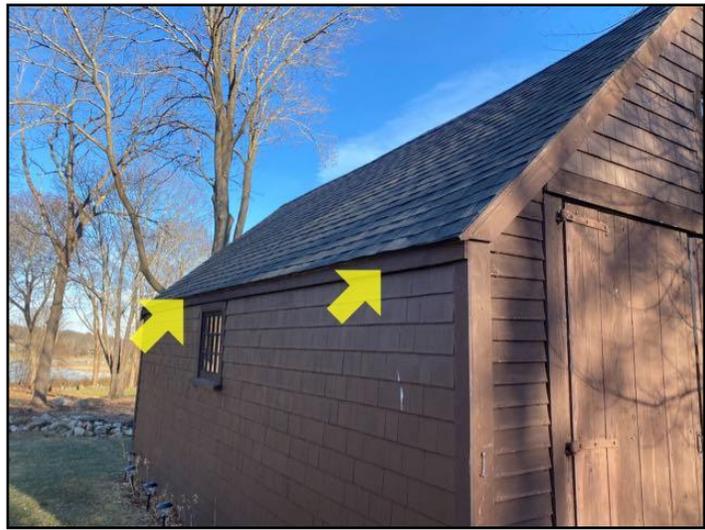
Currently there are no gutters or downspouts installed on the small gable roofed shed structure. Left unmanaged this water will simply drain around the foundation and down the wood siding. Consider installing properly sized gutters and downspouts for this secondary structure. Also, make sure the downspouts drain away from the foundation of the building once installed.

Gutters and downspouts recommended

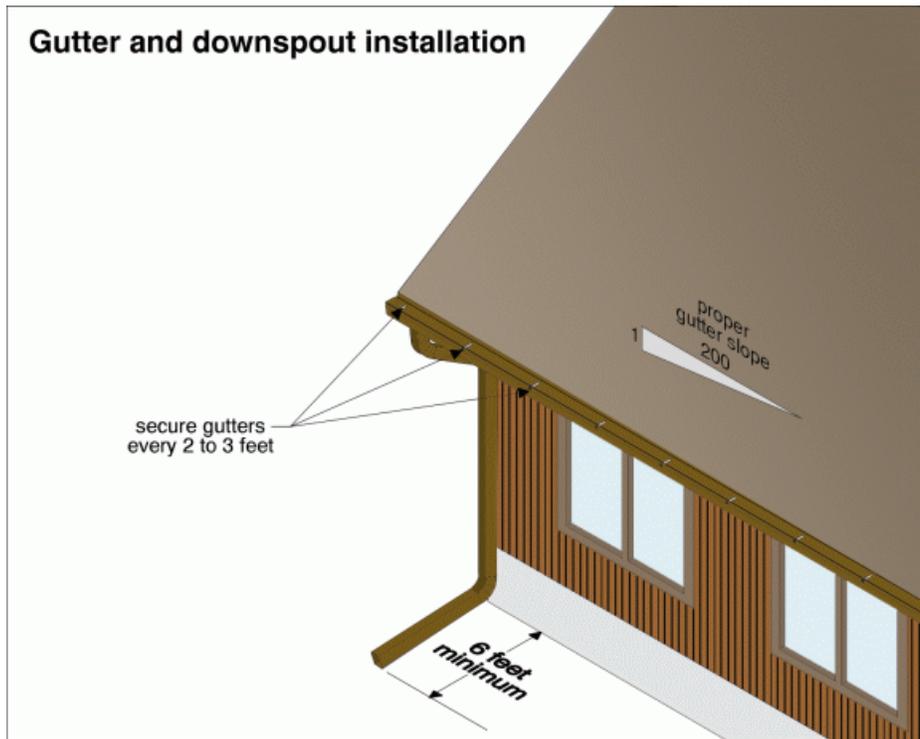
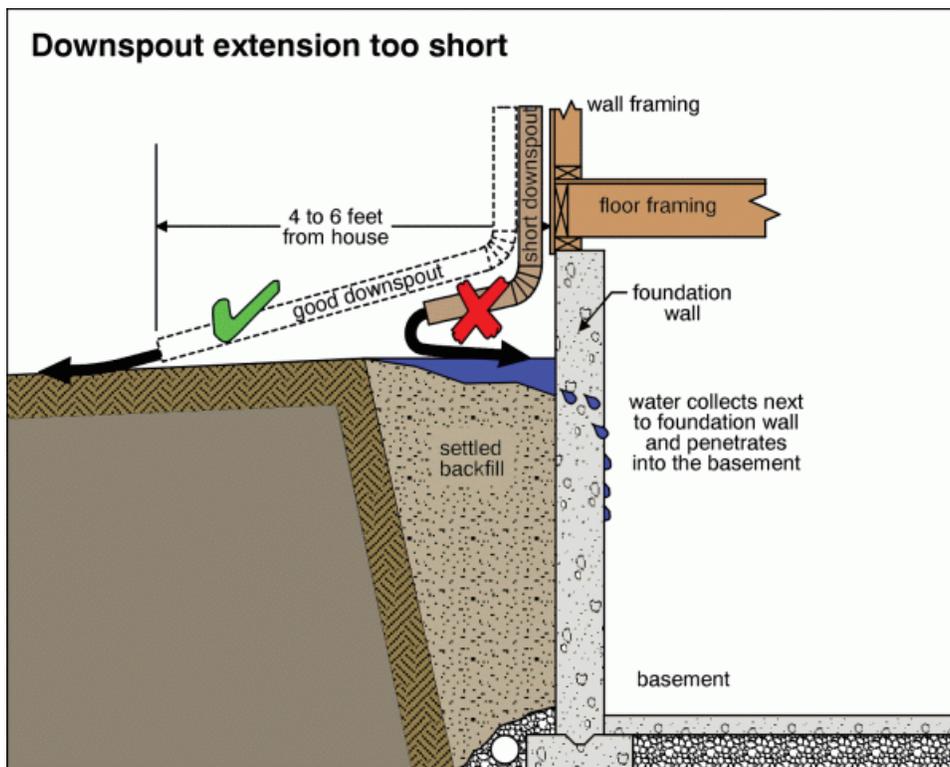
Nearly all of the downspouts on the home are releasing at the footprint of the foundation. This will drastically increase the likelihood of water gaining access to the substructure of the home. In fact, general moisture levels throughout the basement were elevated, (17-20%). This suboptimal drainage configuration plays a big part in this condition. As with any structure, exterior drainage should be addressed aggressively and comprehensively. Discuss further with a qualified contractor.

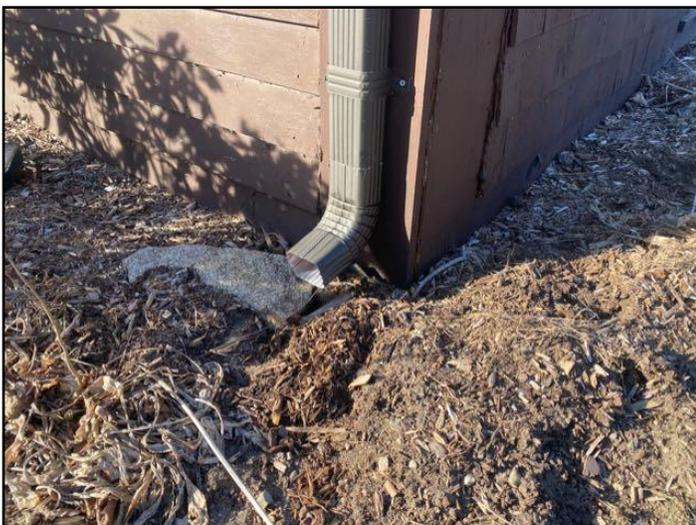
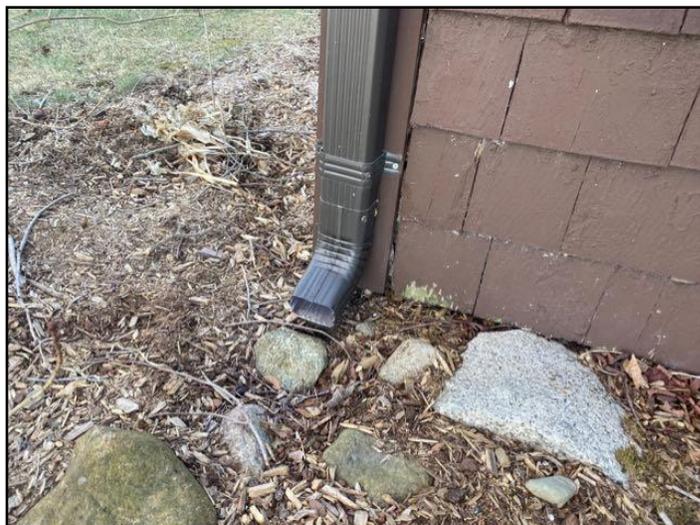
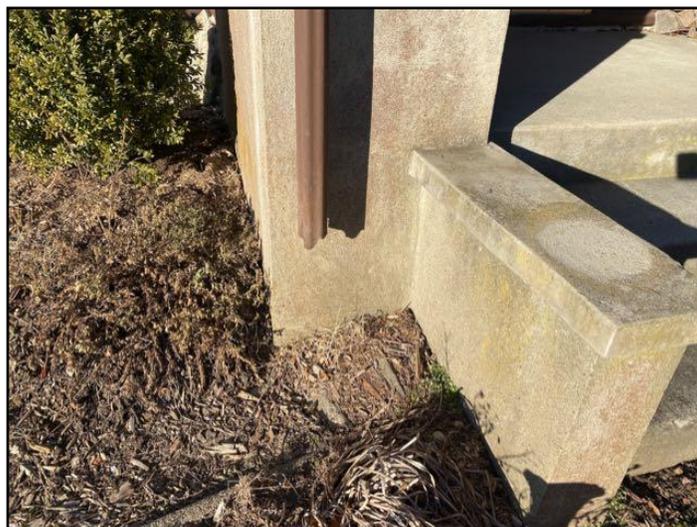
Improvements to drainage strongly recommended

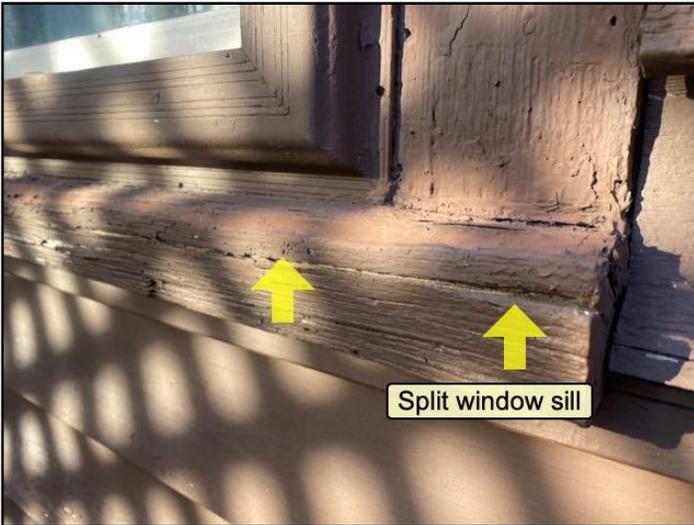
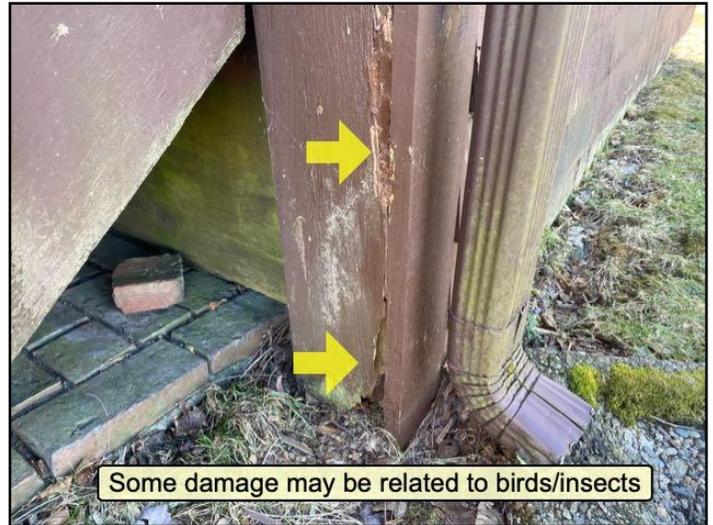
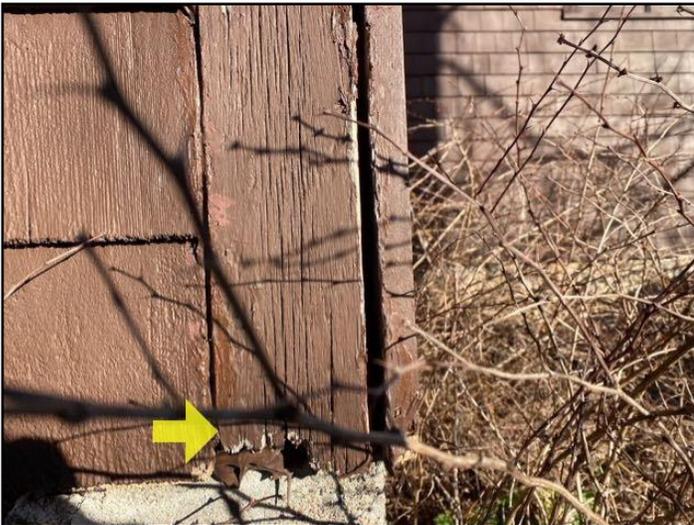
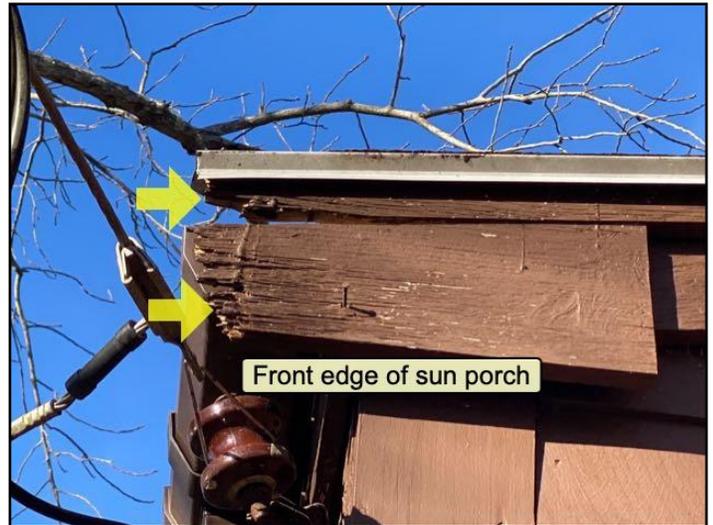
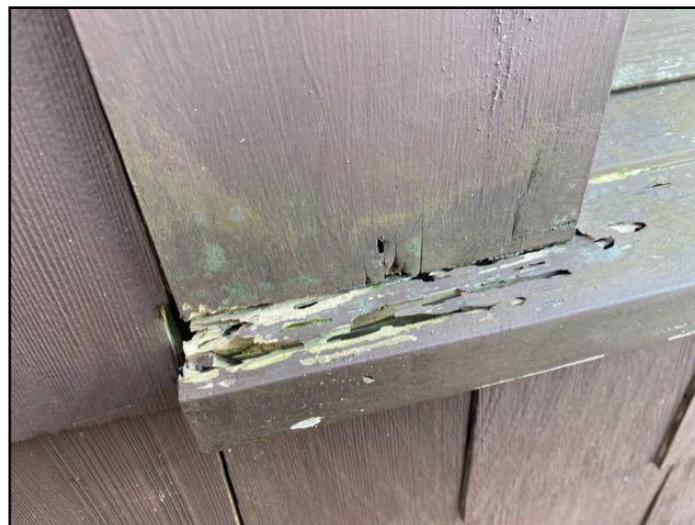
There are numerous areas of rot in the wooden trim on the dwelling. These examples are only from first floor features. It is highly likely that other examples, not captured here, exist elsewhere on the building. All area of decay to trim and siding should be properly repaired by a qualified contractor.

Example of decay

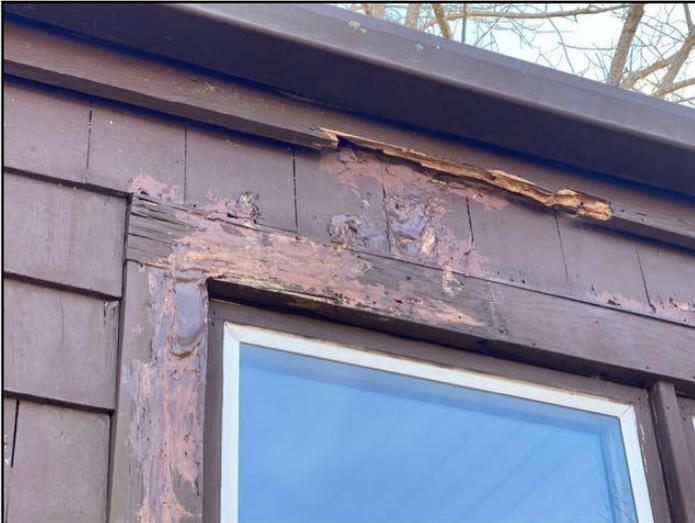
Numerous examples of what appear to be bird or insect damage are present in siding and trim on the rear, left porch. Further evaluation by a qualified pest contractor will help further analyze the sources of damage. All areas of damage to siding and trim should be promptly repaired by a qualified contractor.

Damage to fascia board and window trim

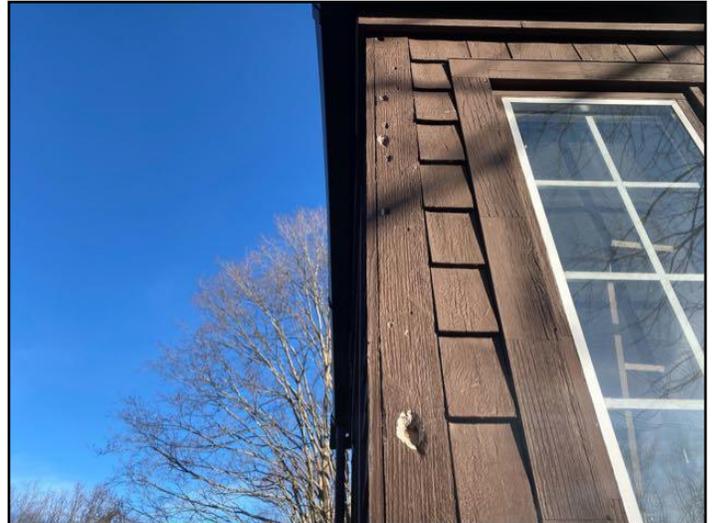
Damage to siding and trim

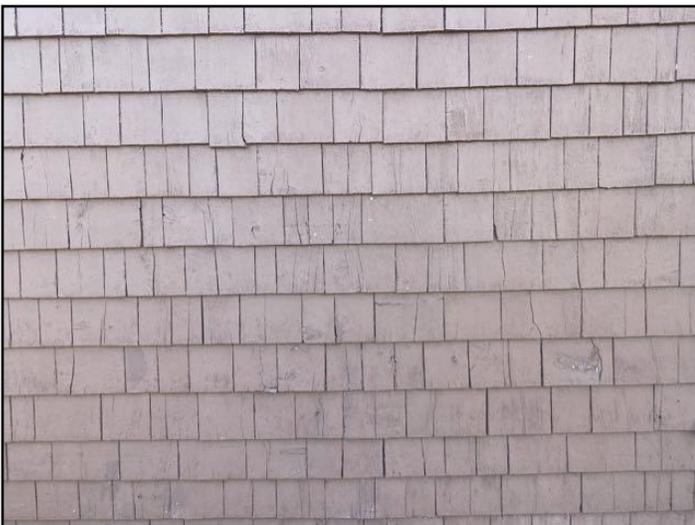
The wood shingle siding on the building is well into its useful life. Significant areas of cracked, damaged, buckling and/or lifting shingles are present, particularly along the right gable end and the rear elevation. While not an item of immediate concern this type of wear is generally considered to be the visual signs of depreciation. At some point in the future, these exterior elevations, starting with the right gable end, will need to be re-sided. This eventual improvement will represent a considerable expense. Recommend you gain a ballpark understanding of what that cost may be and plan accordingly.

Right elevation shingling

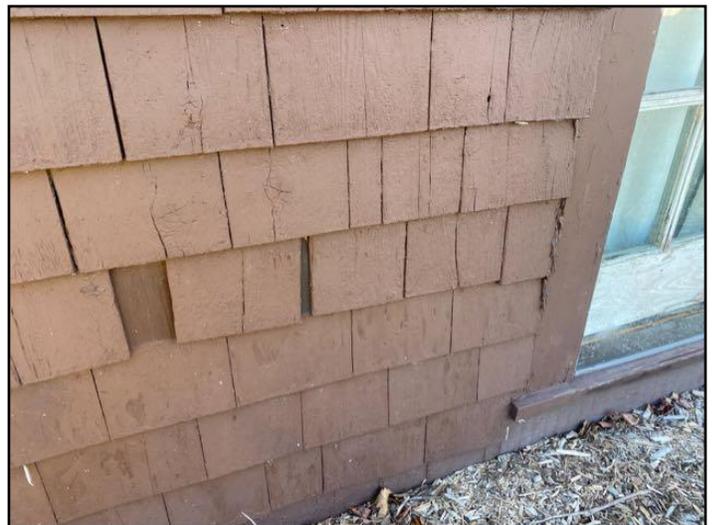
Example of failing siding

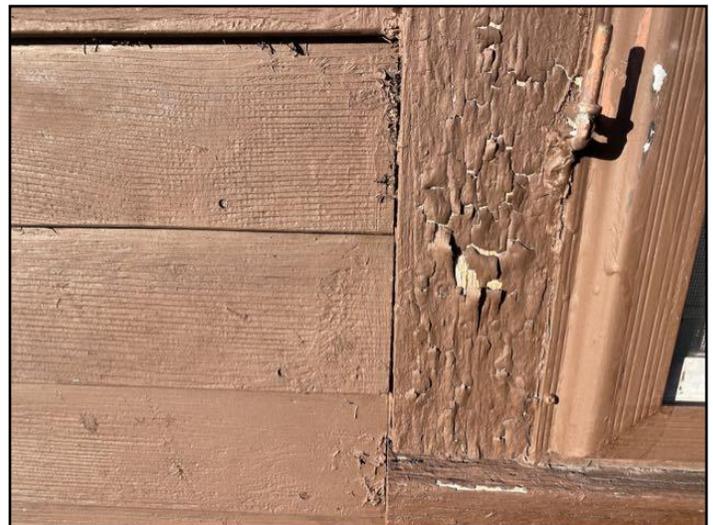
Detail of failing paint films

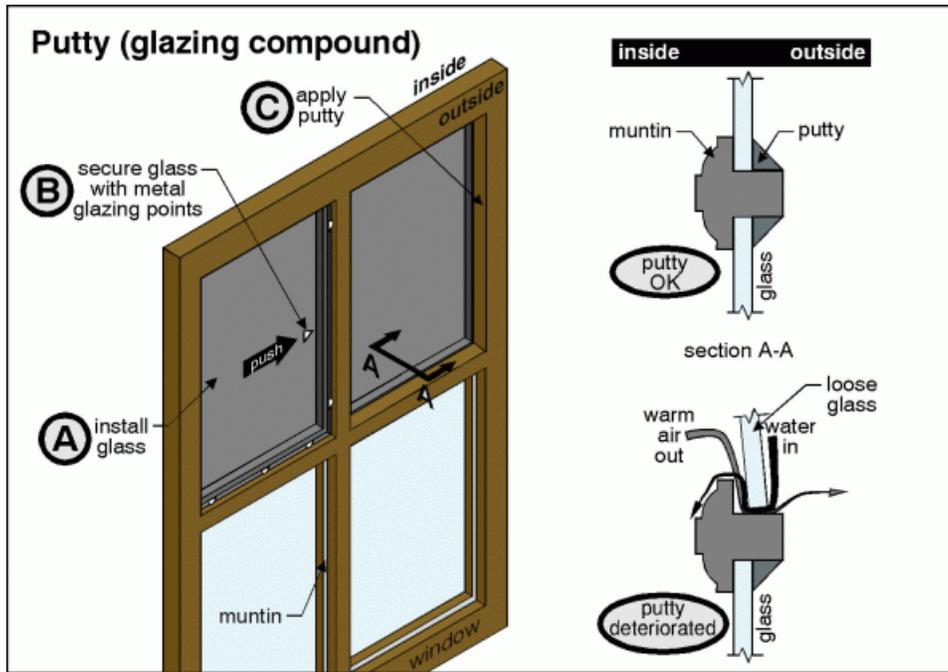
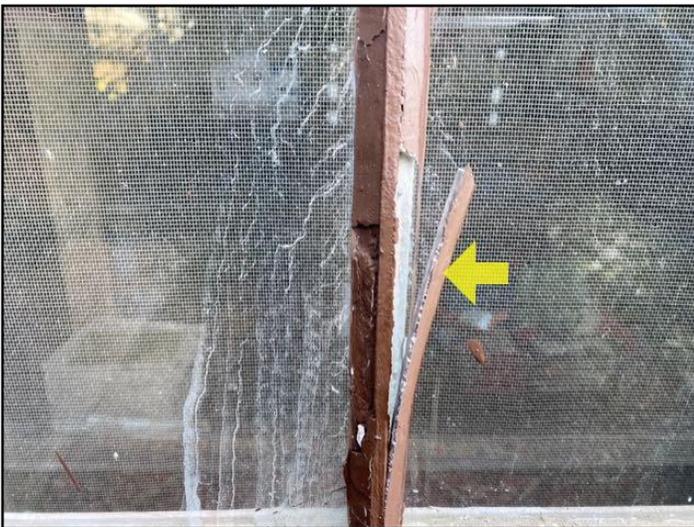
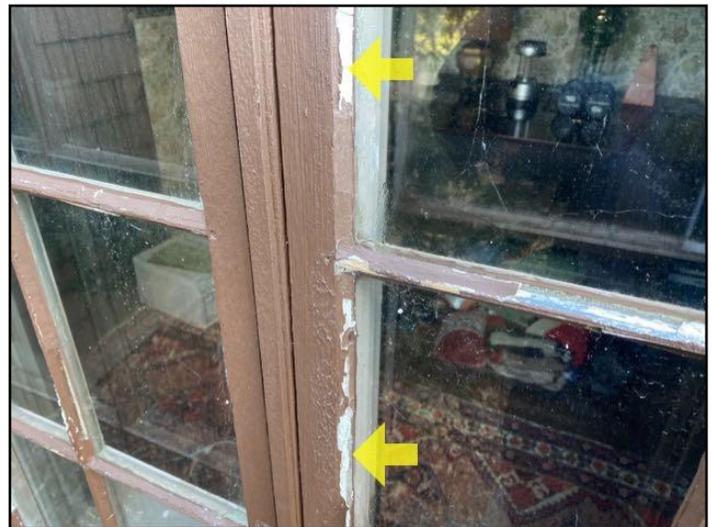
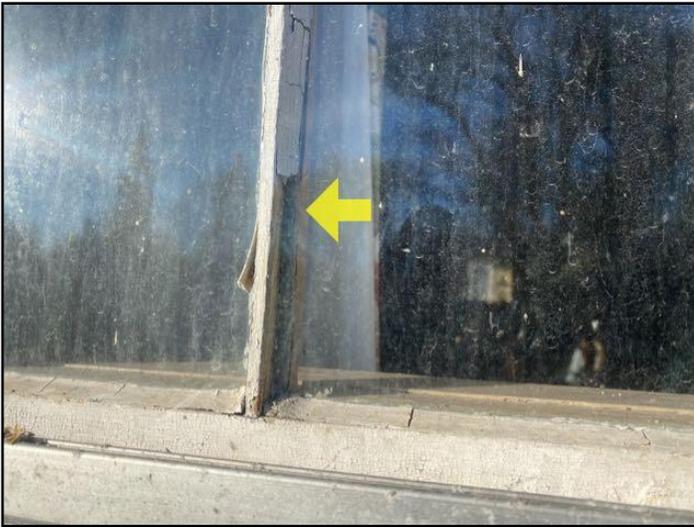
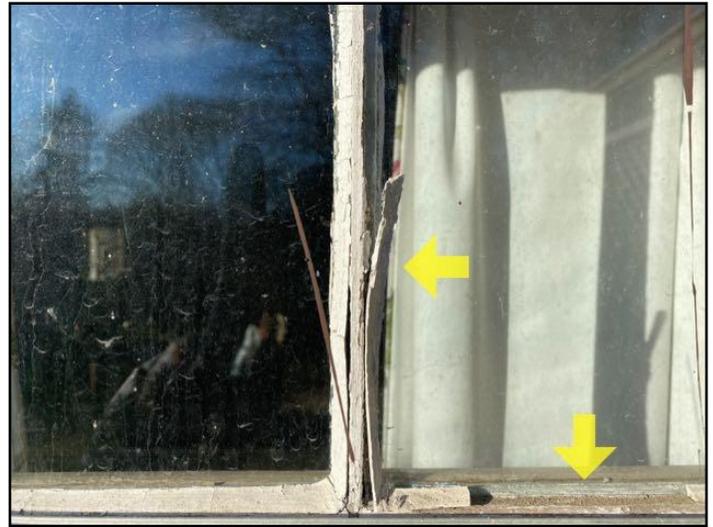
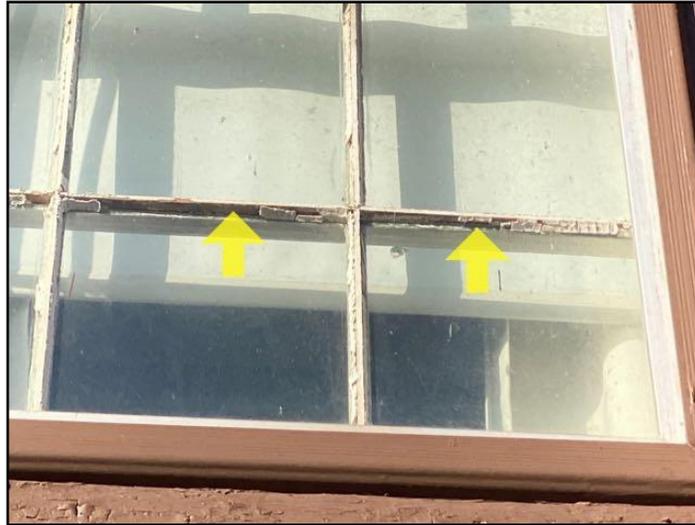
There are many examples of failing window glazing on many wooden sash windows in the home. At some point, repairs to the window glazing will be required.

Putty missing, cracked or deteriorated

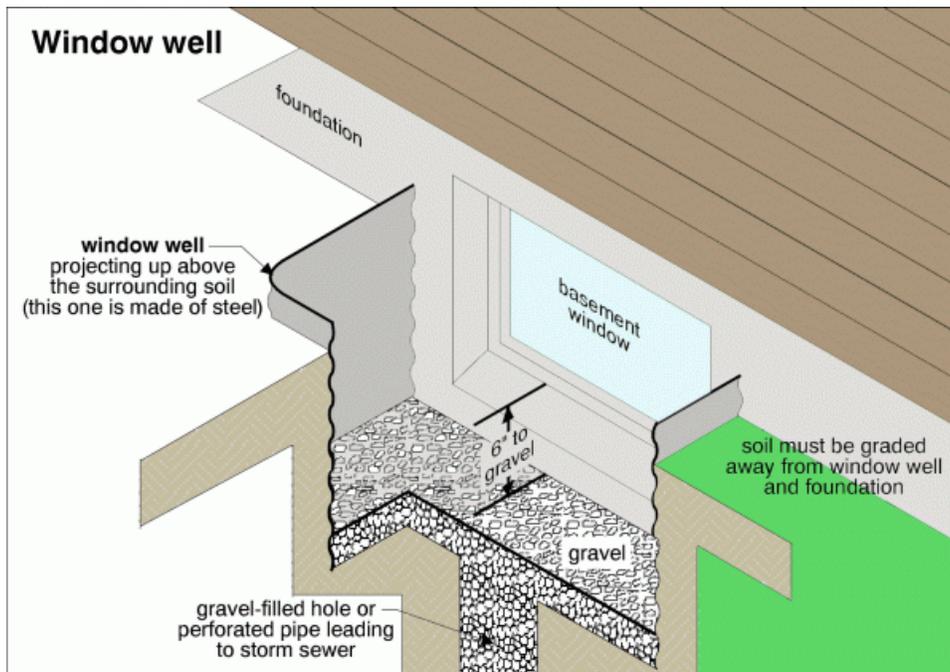
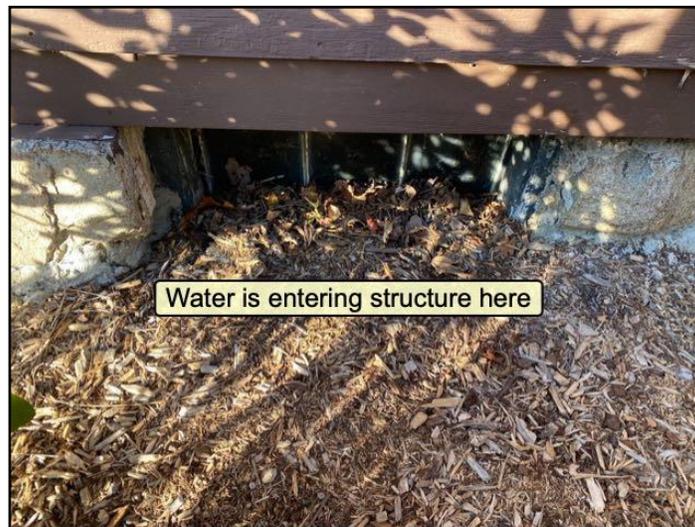
It was noted that a front foundation window was at grade level. This configuration drastically promotes the likelihood of water entering the substructure at this area. It is strongly recommended that you consider installing a foundation window well in this location. Discuss further with a qualified contractor and proceed as recommended.

Improvements recommended @ foundation window

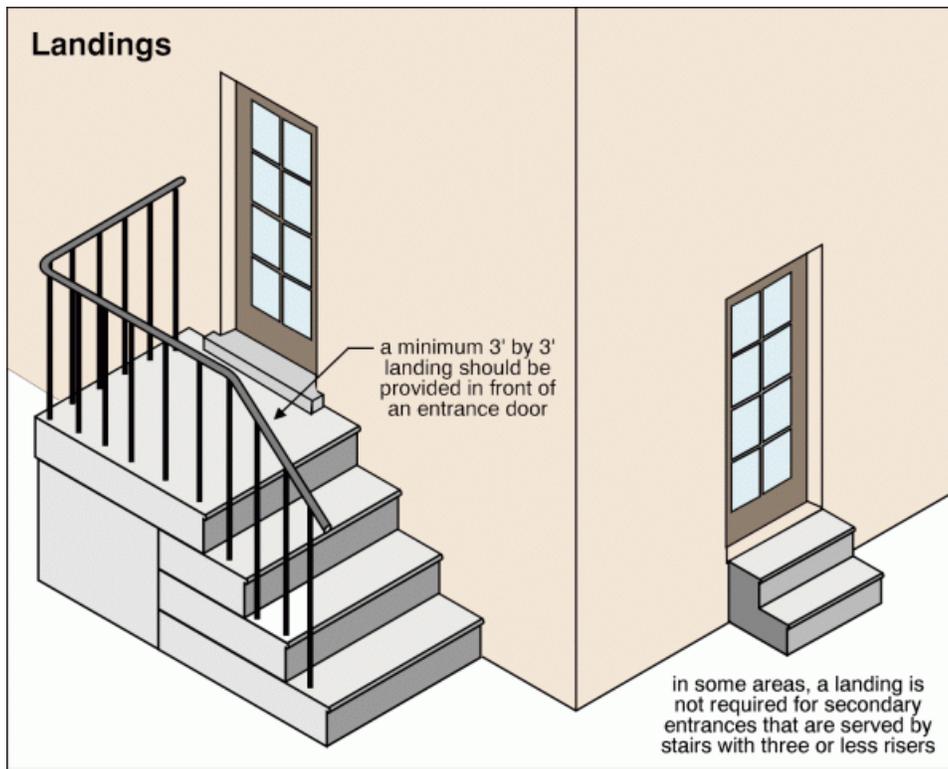
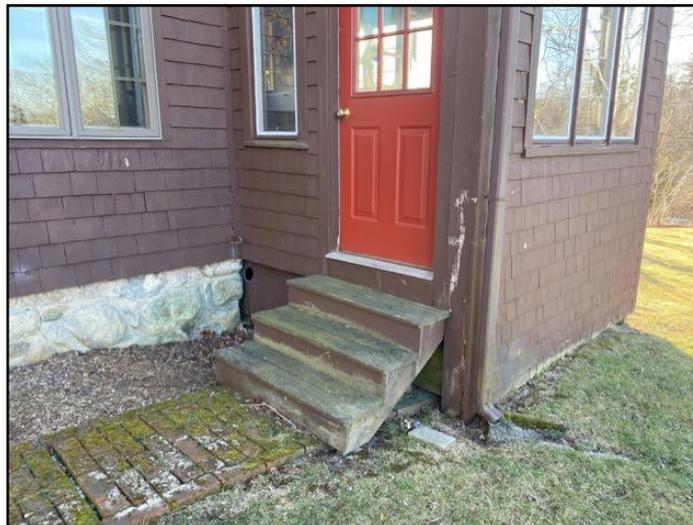
The exterior stair leading into the rear entry may represent a safety hazard on the property. Currently this door opens to an immediate flight of stairs, with no landing provided. This is generally not a recommended configuration as someone may lose their balance opening the door. Recommend you consult with a qualified carpenter and consider improving this installation.

Improvements to entry recommended

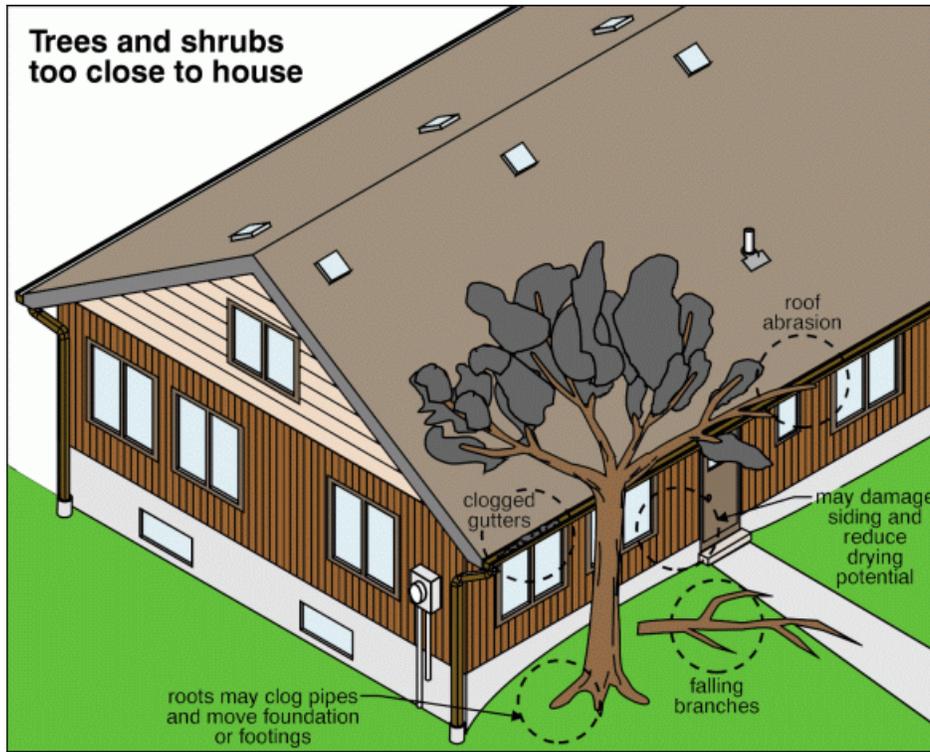
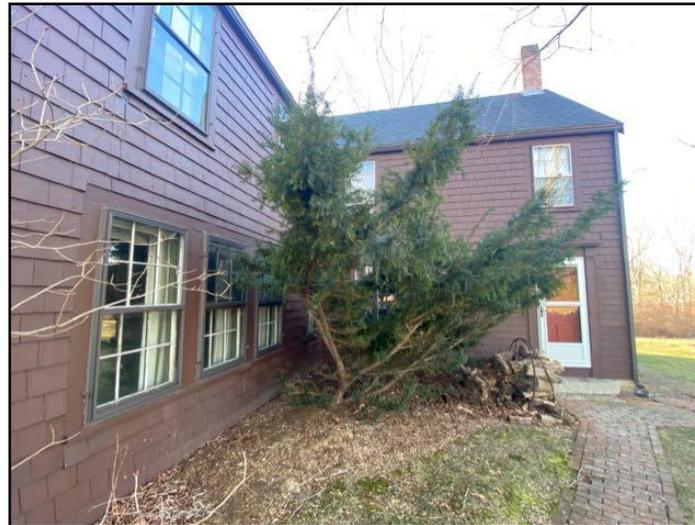
Some plantings around the structure have outgrown their intended shaped design. Any vegetation that is within six inches of exterior siding should be pruned back away from the building. Vegetation against siding can transfer insects and trap moisture, increasing the likelihood of damage or decay.

Some vegetation encroaching

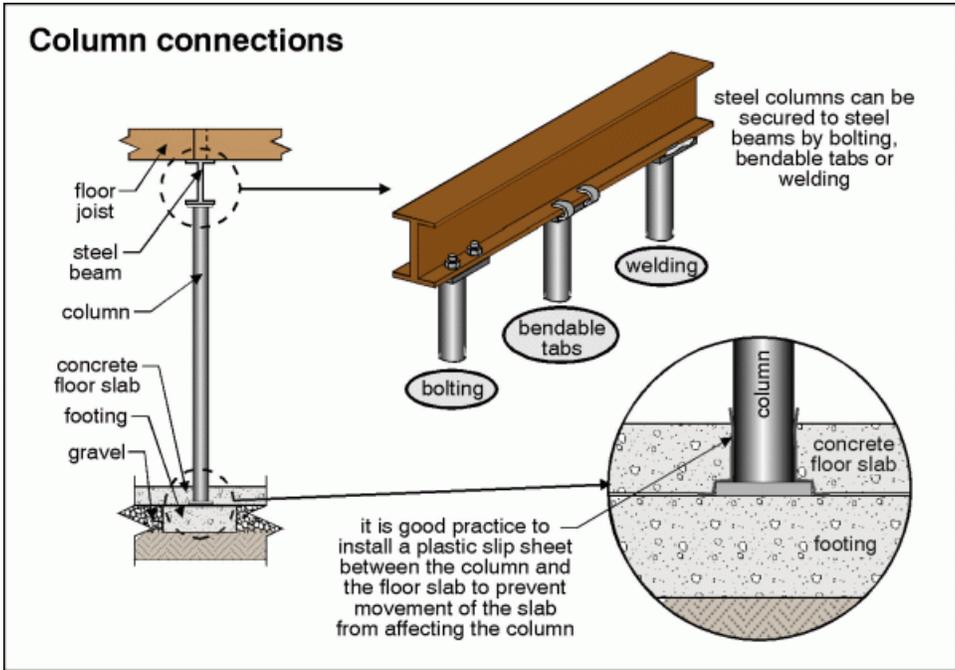
A secondary wooden post-and-beam support has been installed, running front-to-back, in the cellar hole. This installation does not reflect proper practices. The posts are not properly secured to the beam, nor are they secured properly to the floor. In fact, the front post is loose to the touch. Recommend you consult with a qualified contractor to have this installation improved.

Post and beam not secure
